## Holden Aftersales - *Parts News*

**BULLETIN NO: PARTS 2014 – R3300**  
**DATE: 4TH JULY 2014**  
**AUDIENCE: COLLISION REPAIR INDUSTRY**  
**SUBJECT: COLLISION REPAIR TO FASCIA**  
**WITH SBZA AND RCTA RADAR**

Please be advised that Holden has published collision repair recommendations for the bumper fascia on VF Commodore model variants which have Side Blind Zone Alert (SBZA) and Rear Cross Traffic Alert (RCTA).

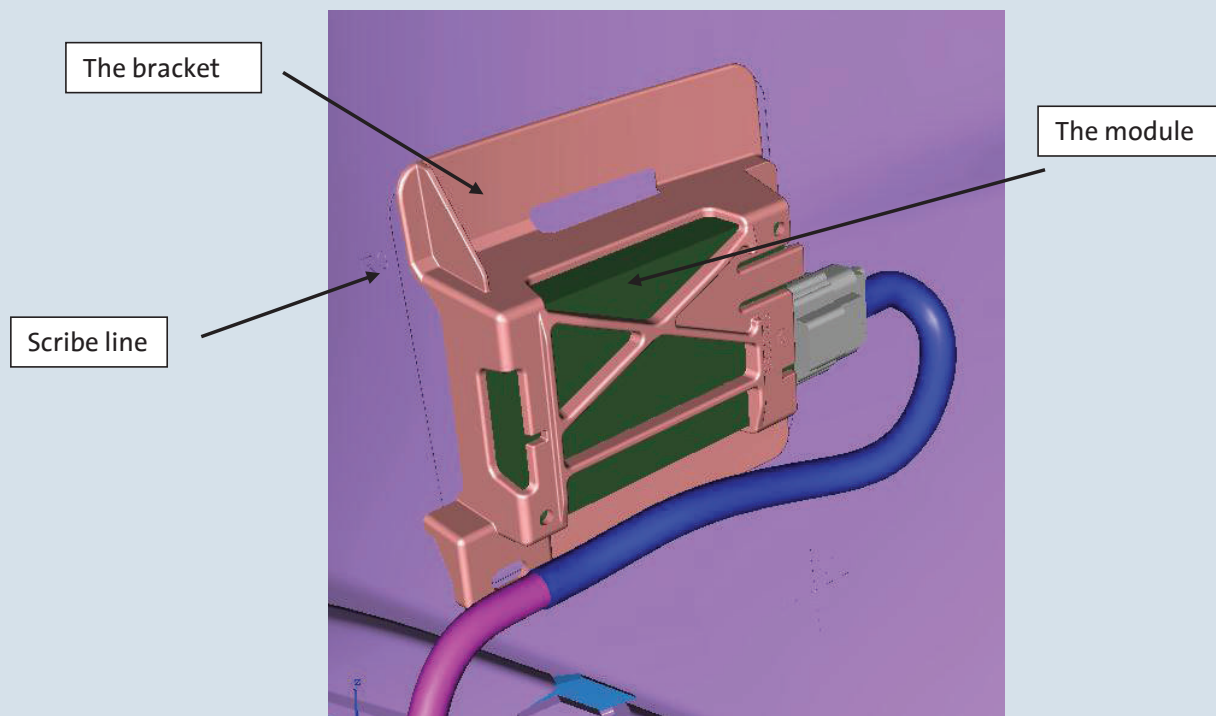
## SCRIBE LINE

- Solid line embossed on the B class surface of the fascia

## FIELD OF VIEW (FOV)

- The Field Of View is defined as the field within the scribe lines embossed on the B-Class surface which extends through to the A-Class surface

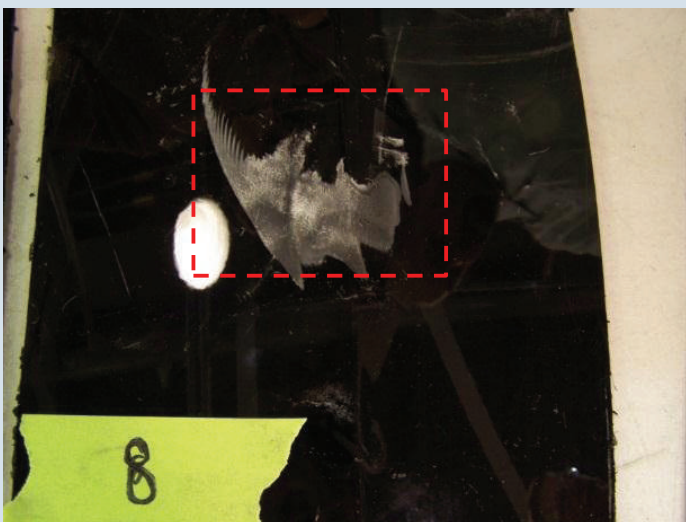
### ACCEPTABLE REPAIR #1

- Fascia presented with scuff mark may be repaired
- Area to be sanded down Poly-Flex Bondo or similar applied to surface
- Area repainted

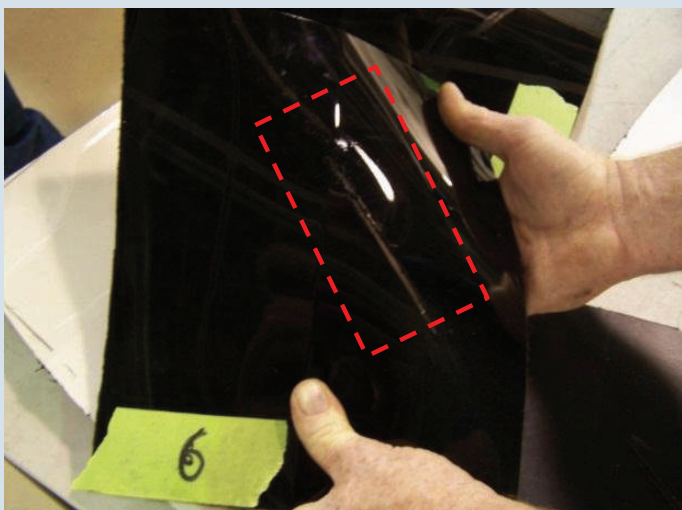
### ACCEPTABLE REPAIR #2

- Fascia with one directional crack that does not exceed the size of the module within the field of

view (FOV) and no penetration to the B Class surface may be repaired.

- Area to be sanded down
- Cracked plastic welded to repair
- Poly-flex Bondo or similar applied to the surface
- Fusor 142 plastic repair material or similar applied
- Area repainted

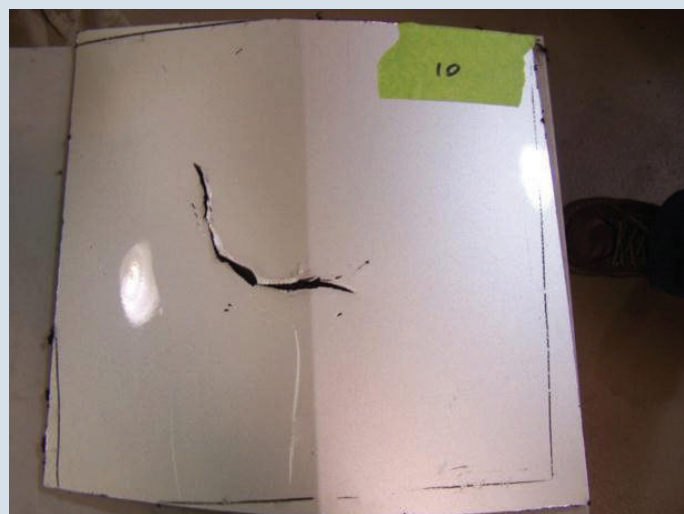
### UNACCEPTABLE REPAIR #1

- Fascia with crack that is not a straight line, or exceeds the size of the module within the field of view (FOV) must NOT be repaired
- Fascia replacement is required
- Any damage that penetrates through the B class surface in the field of view (FOV) of the radar must not be repaired -fascia replacement is required.
- Damage to fascia that causes damage to bracket will require fascia replacement regardless of fascia damage. Repair to brackets or replacement of

brackets can introduce abnormalities to B class surface impacting radar performance. It is for this reason that when a new fascia is purchased, the brackets are already welded on.

- Repairs carried out on un-acceptable damage may result in an increase in false positives.

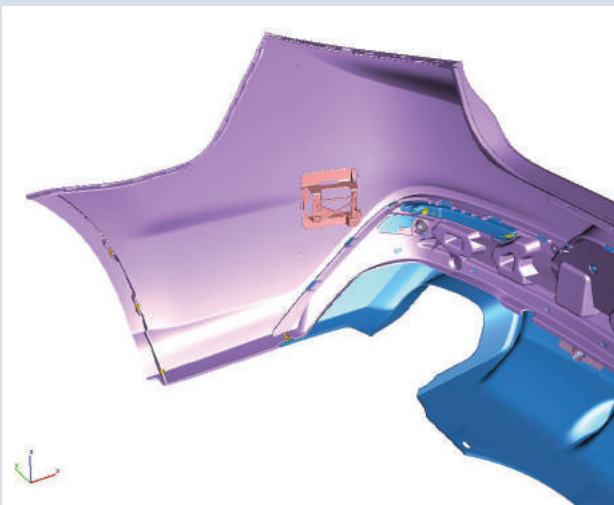
*The VF fascia will be supplied with the brackets already welded on*
