# Porsche Cayenne rocker panel sectioning change

Porsche has revised a sectioning procedure on the Cayenne SUV. For those who have the occasion to work on these vehicles, the change is worthy of note.

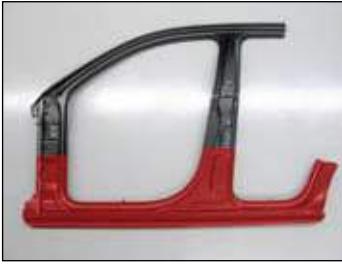
**U**p until recently, there was only one procedure to replace the Cayenne outer rocker panel, regardless of the extent of the damage. That procedure involved replacing the entire outer rocker panel (see Figure 1). Damage that was confined to the dogleg area of the C-pillar became a major operation that extended into the A- and B-pillars.

Figure 1 - Before earlier in March, the only procedure in the service information for replacing the outer rocker panel was the entire outer rocker panel.

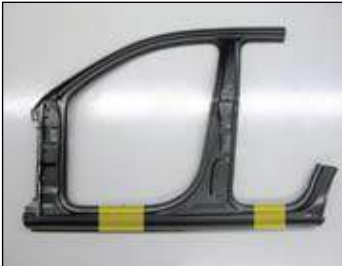
Figure 2 - The outer rocker panel may be sectioned in either of these two shaded areas.

The new procedure adds two possible sectioning locations in the outer rocker panel, at either of the two shaded areas shown in Figure 2. This allows replacement of only small portions of the outer rocker panel. What does not change, is that no matter how much of the outer rocker panel is replaced, the replacement portion must be cut out of the front outer aperture shown in Figure 3. In addition to the complete outer rocker panel, the front aperture service part includes the entire outer A-pillar, B-pillar, and the front portion of the roof rail. The outer quarter panel, which makes up the rest of the side aperture, is also available as a service part.

All of the sectioning joints are open butt joints, and Porsche recommends the cut-and-join method to make the matching cut lines. The method is never called cut-and-join in the service information, but that is the procedure shown. The replacement part is first cut to leave a 50 mm (2 in) overlap at each joint location. The cut is then made across both the replacement and existing outer panel at the same time at the joint line. A root gap, about the width of the saw blade, is recommended.

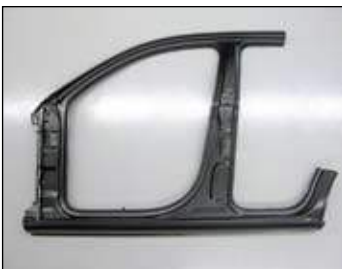
Figure 3 - This is the service part that the outer rocker panel must be cut from, no matter which procedure is used.

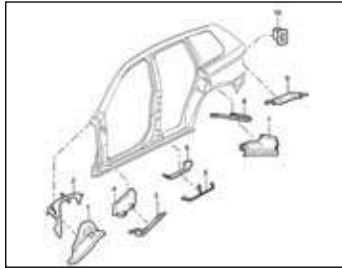
Figure 6 - These inserts are the same part as used during the original build.

There are foam inserts in the pillars and wheelhouse areas, used for sound-deadening purposes, which must be replaced during the repair. This is usually done with cartridge foam or foam blocks. With Porsche, the replacement foam inserts are the same part that is installed during the original build (see Figure 6), although the installation of the inserts is different. The parts catalog calls these inserts "sound absorbers." The inserts are mostly flat profiles, usually plastic, with a

small strip of expandable foam around the outer perimeter. During vehicle assembly, the foam expands when the body shell is in the bake oven, locking the inserts in place. During replacement, there isn't enough heat buildup, even when baking in a spraybooth, to expand the foam. So butyl tape and a heavy body seam sealer take the place of the expanding foam. A strip of butyl tape is applied to the edge of the insert, which is pressed into position. The heavy body seam sealer is applied along the remaining edge to seal the insert into position between the panels.

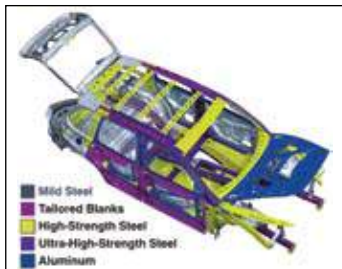
The Cayenne body is a study in advanced high-strength steels (see Figure 7). The body is primarily high-strength steel, though the outer quarter panel and rear floor pan are mild steel and the hood and door window frames are aluminum. UHSS is used on the tubular reinforcement in the rocker panels, upper A-pillar reinforcements, inner B-pillar reinforcements, door intrusion beams, a floor pan crossmember between the B-pillars, and the floor pan tunnel. The UHSS inner B-pillar reinforcements and the upper A-pillar reinforcements are transformation induced plasticity (TRIP) 700 steel. The complete lower rails and rocker panel reinforcement tubes are dual-phase (DP) 600 steel. Tailored blanks are used on the outer front and rear rails, roof rails, and the door shells to vary the strength of the steels within the same part. Porsche uses boron-alloyed steel on several vehicles, especially on the door intrusion beams, though there is none on the Cayenne.

Figure 7 - Advanced high-strength steel is used throughout the Cayenne body.
