Toyota Integration Relay Failure

Integration Relay Failure Caused From Service Repair Model: Camry ASV50, AVV50 Aurion GSV50

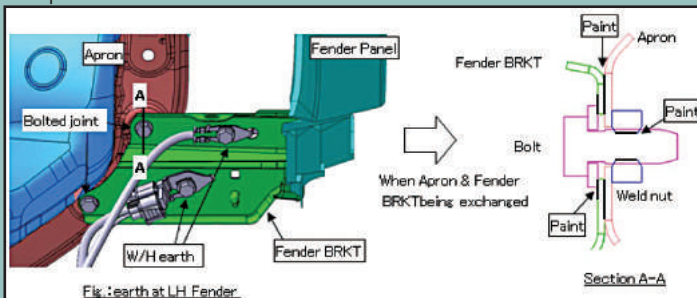
Investigations initially found the integration relay had over heated and failed. Further investigations traced the cause of the overheating to a poor earth point to the integration relay. This poor earth was caused by paint between the fender bracket and apron, after body repairs had been carried out. Ref picture below.

Remove the apron and inspect mounting locations both front and back. The mounting areas should be free of paint, tape etc. The mounting areas should be bare metal.

The back of the bracket has captive nuts, ensure the threads in the nuts are free of paint.

Ensure that the bracket surfaces where the earth bolt and washer make contact are cleaned back to bare metal to achieve a proper earth.

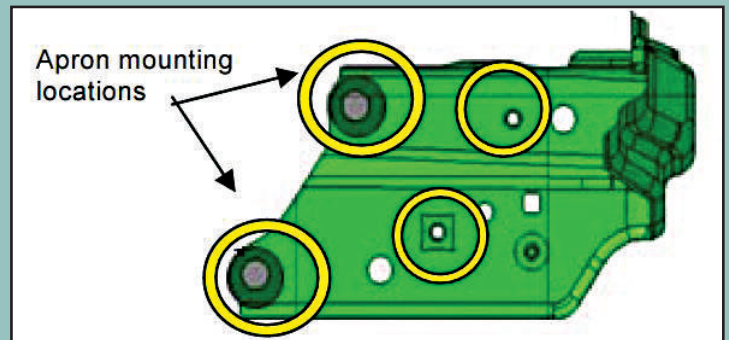
Circled areas are the critical bolt mounting areas. (see illustration top of next column)
