Parts Techline: 2014-PT279
From: Parts Technical

VE/WM Rear Side Door Replacement

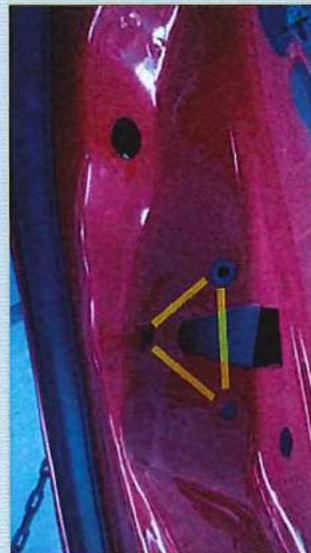
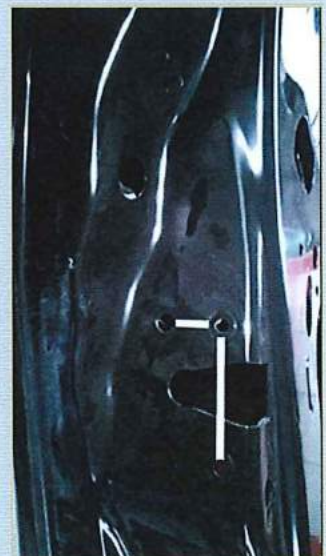
1) Rear Side Doors

New VE/WM rear side door service design has been created that incorporates the inner panel design from VF/WN vehicles. Some door component parts fitted in production are not suitable for installation to the new design service doors and some are not fitted in exactly the same way as on the production door design. When replacing a VE/WM rear side door additional components will also need to be purchased and fitted. This will also impact any subsequent service replacement of these components.

The new service door has three latch mounting points in an "L-shaped pattern" (see holes linked by white lines in below photo on the right). The production door design had three latch mounting points in a "triangular pattern" (see holes linked by yellow "triangular pattern lines" in below photo on the left).

It is important to check the design of the fitted component parts prior to ordering to ensure that all required parts are included.

Additional parts will be required when fitting new design service rear side doors

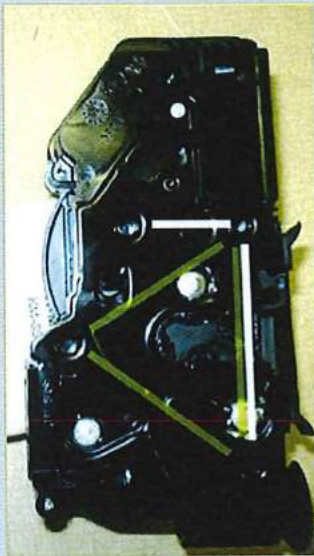
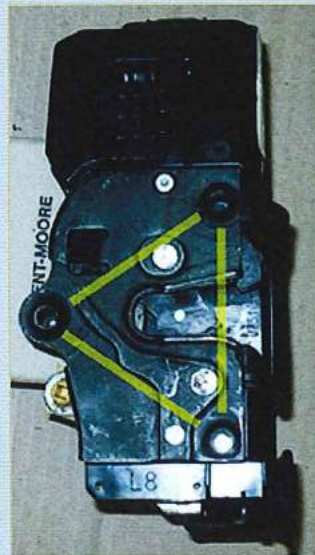
2) Rear Side Door latches

To identify the latch remove from the door and check whether the latch has threaded holes in an “L-shaped pattern” (see holes linked by white lines in below photo on the right), or whether there are only three threaded holes in a “triangular pattern” (see holes linked by yellow “triangular pattern lines” in below photo on the left). These will not fit the new service doors.

Rear door latch with four mounting points – “triangular pattern” & “L-shaped pattern”

These will fit both the production door and the new service door. If the existing door latch only has three threaded holes in the “triangular pattern” you will need to order a replacement latch and cables (ask for these when ordering the new door shell).

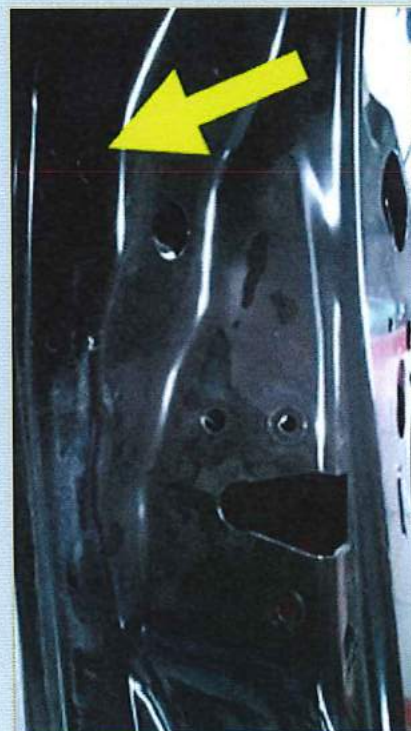
4) Plugs for door handle access holes

The 10mm diameter hole nearest to the door skin (shown with yellow arrow) was not present on original doors. This plug needs to be ordered and fitted for new service doors.

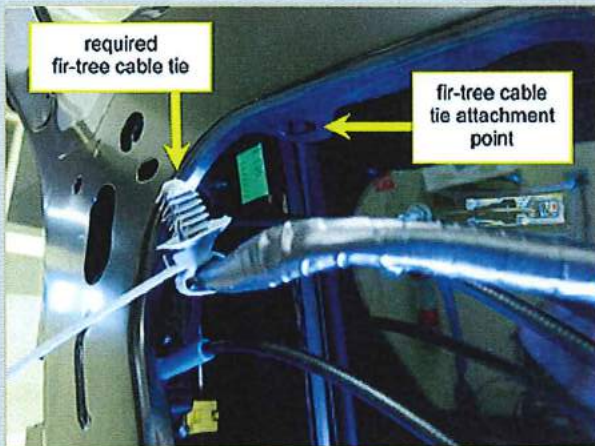
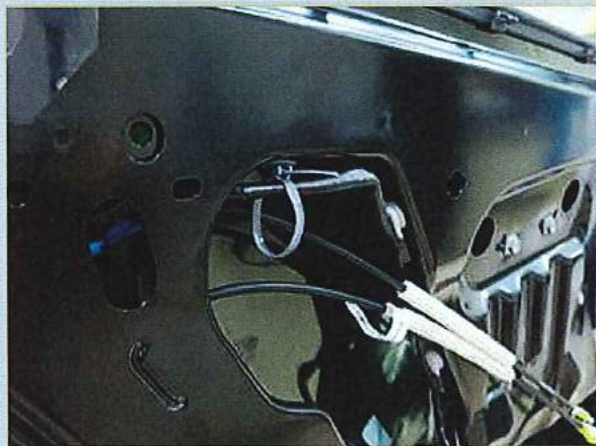
5) Door harness retention

Depending on the design level of wiring harness you intend to use, additional fir-tree cable ties may be required. The wiring harness retention near the door latch and near the B-pillar must be inspected and retained as per the process described in the bulletin. Please note that redundant retention clips will need to be removed carefully to prevent rattles

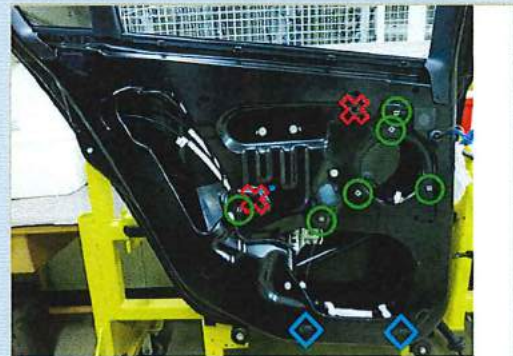
6) Door trim retention

Due to the new service door inner panel being a common design with VF/WN you need to identify the VE/WM door trim retention holes and install the appropriate retainers in these holes only. Refer to the below photo regarding the location of retainers. Installing retainers in the wrong holes will result in rattles and/or inability to retain the door trim correctly.

Do not use – VF only

Door trim attachment push-in steel nut with rubber seal – p/n 11610510 – quantity 2
-

Speaker / inside handle / pull cup push-in nylon nut – p/n 90230846 – quantity 6
-

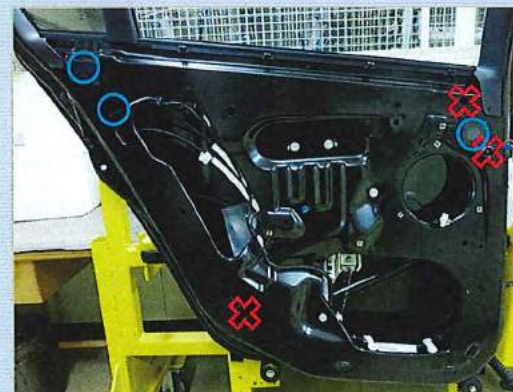
7) Sealing tape (Mylar patch)

Pieces of adhesive Mylar tape are required in certain locations to stop moisture from the door cavity entering the back of the door trim. The photo below shows the holes in the door inner which need to be covered by this Mylar tape before the water deflector is attached

Do not cover – door trim alignment hole or window switch wiring harness hole

Seal hole with adhesive Mylar patch – 92196496 - quantity 3 per door
-
