# Holden Aftersales.

## Parts News.

**Bulletin No:** Parts 2014 – R3300  
**Date:** 4th July 2014  
**Audience:** Collision Repair Industry  
**Subject:** Collision Repair to Fascia with SBZA and RCTA Radar

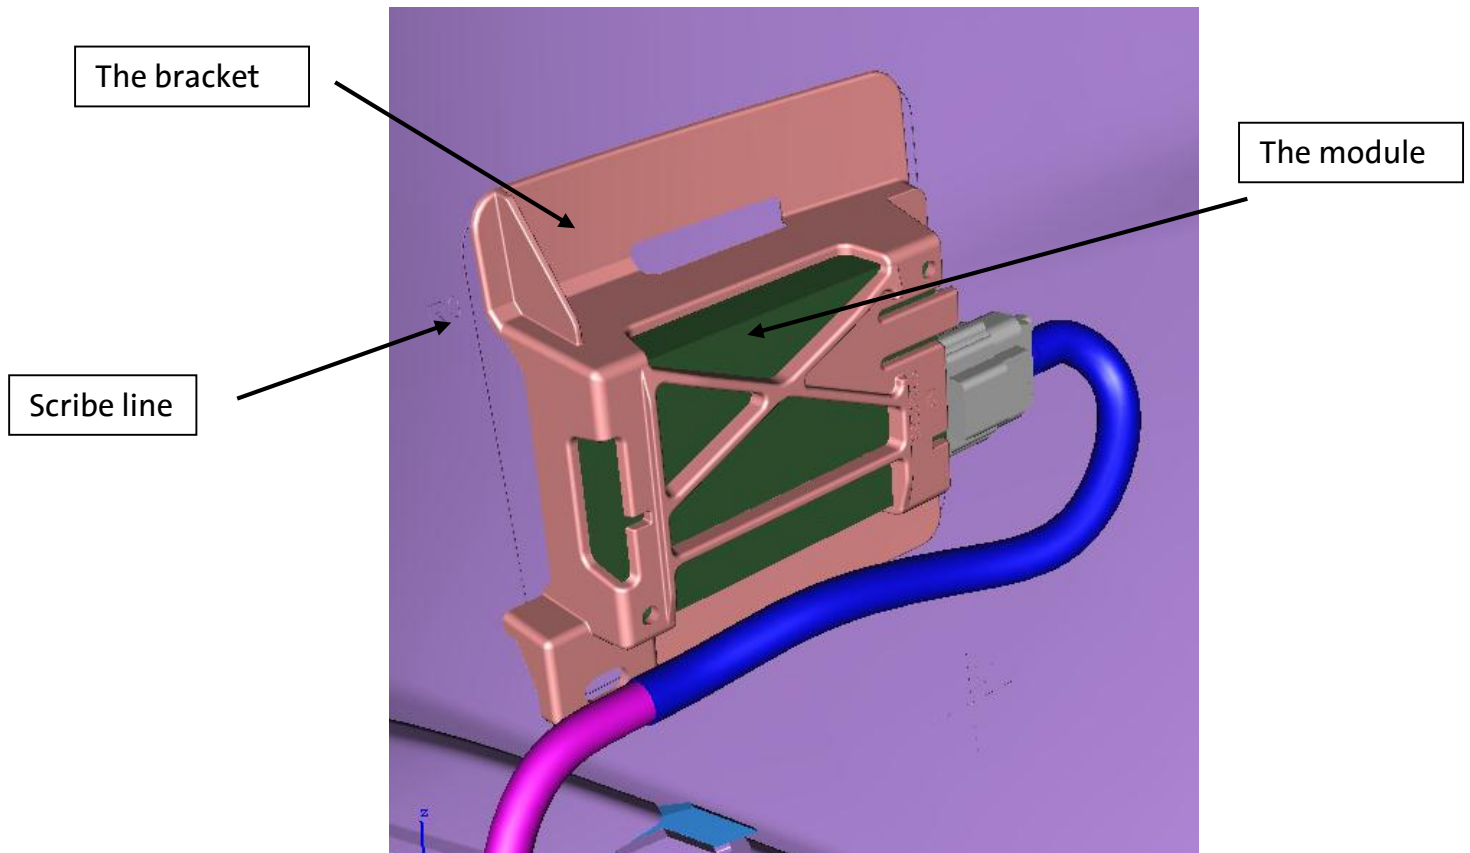
## Glossary of terms:

### Scribe line

- Solid line embossed on the B class surface of the fascia

### Field of view (FOV)

- The Field Of View is defined as the field within the scribe lines embossed on the B-Class surface which extends through to the A-Class surface

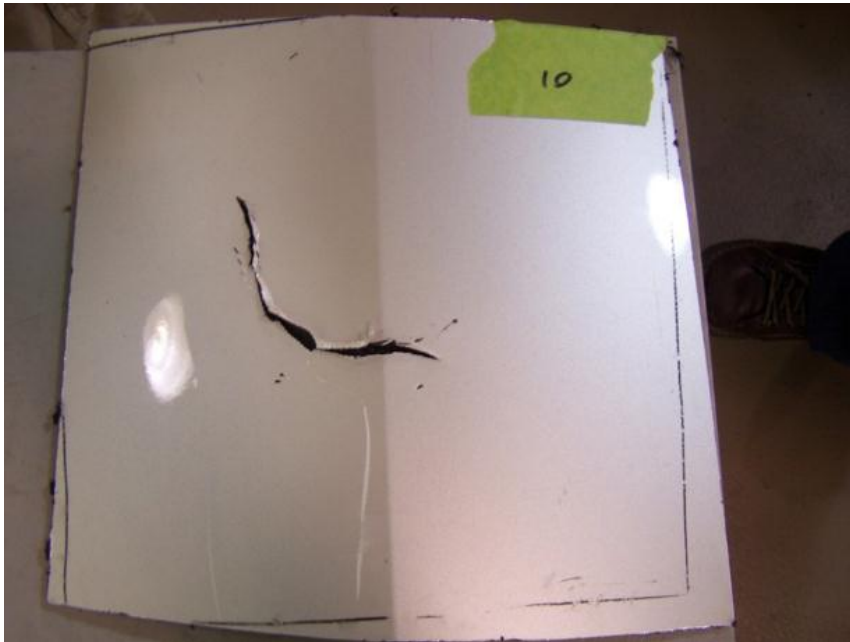
## UNACCEPTABLE REPAIR #1

- Fascia with crack that is not a straight line, or exceeds the size of the module within the field of view (FOV) must **NOT** be repaired
- Fascia replacement is required

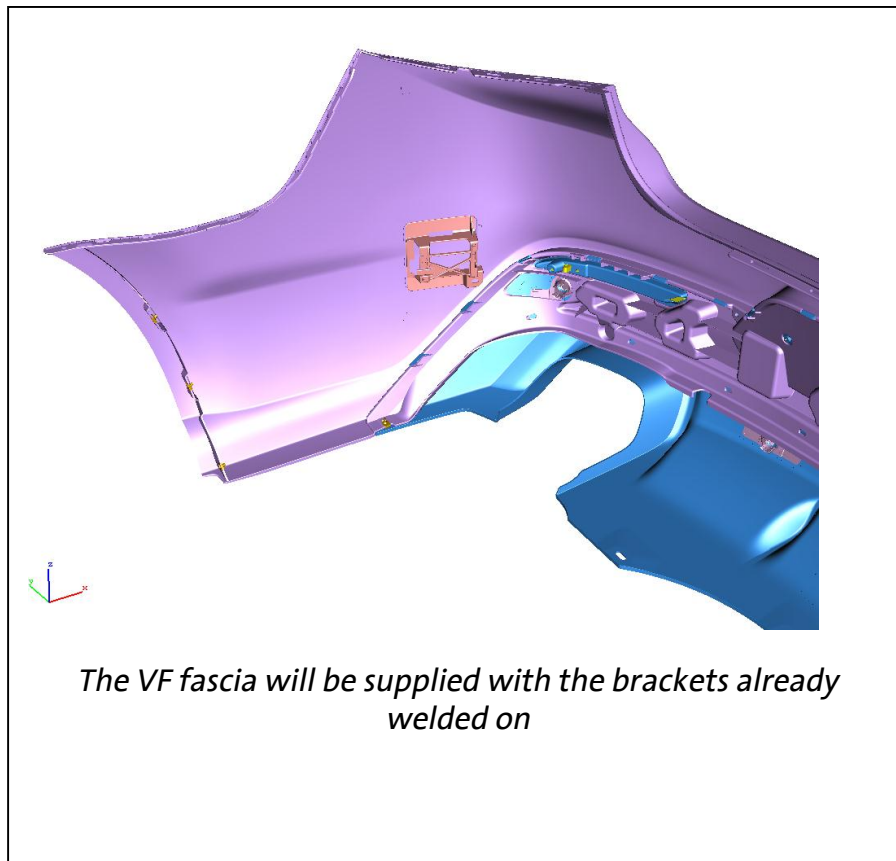
### UNACCEPTABLE REPAIRS CONTINUED

- Any damage that penetrates through the B class surface in the field of view (FOV) of the radar must not be repaired -fascia replacement is required.
- Damage to fascia that causes damage to bracket will require fascia replacement regardless of fascia damage. Repair to brackets or replacement of brackets can introduce abnormalities to B class surface impacting radar performance. It is for this reason that when a new fascia is purchased, the brackets are already welded on.
- Repairs carried out on un-acceptable damage may result in an increase in false positives.
- A false positive is when the systems alert the driver to something that should not be alerted to. E.g. trees, stationary objects, guard rails etc.
