Heat Damage And Stationary Glass

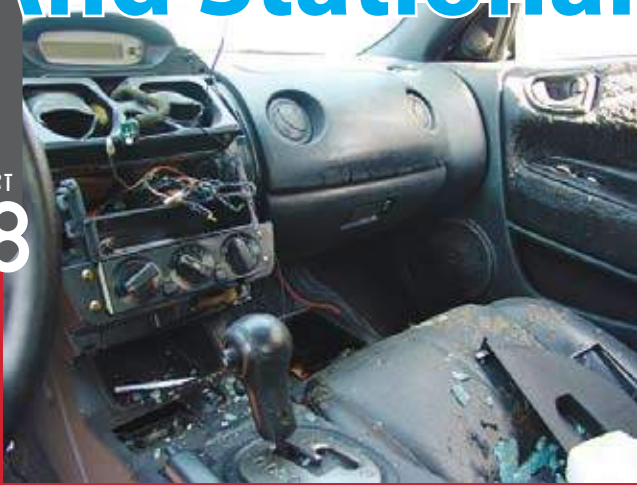
Figure 1 - Fire damage to this vehicle was caused by faulty wiring in the dash panel.

Although some vehicle fires are caused by collisions, many are not. Other causes for vehicle fires include faulty wiring (see Figure 1), fluid leaks, the exhaust system, smoking, and vandalism. A vehicle may also be exposed to excessive heat or fire if it is parked near a burning building or another vehicle. A vehicle that has been damaged by fire requires a close inspection of stationary glass, even if there are no obvious signs of damage. Heat-damaged parts, adjacent to stationary glass, may indicate that the glass should be inspected further (see Figure 2).

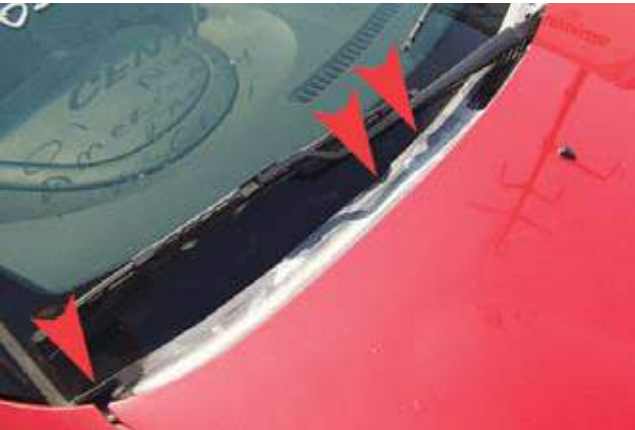
Figure 2 - The plastic trim panel at the bottom of the windshield started to warp from excessive heat, caused by a vehicle fire.

Inspecting stationary glass on a fire-damaged vehicle may include checking for a smoky haze or stain that cannot be removed using conventional glass cleaners and techniques. Permanently stained glass should be replaced because the reduced visibility is a safety hazard. Also look for signs of delamination on laminated glass. Delamination is when one or both layers of glass begin to separate from the inner polymer layer. This may appear as a bubbling near the edge of the glass. Glass that appears to be delaminating should be replaced because the structural integrity of the glass is likely to have been compromised.

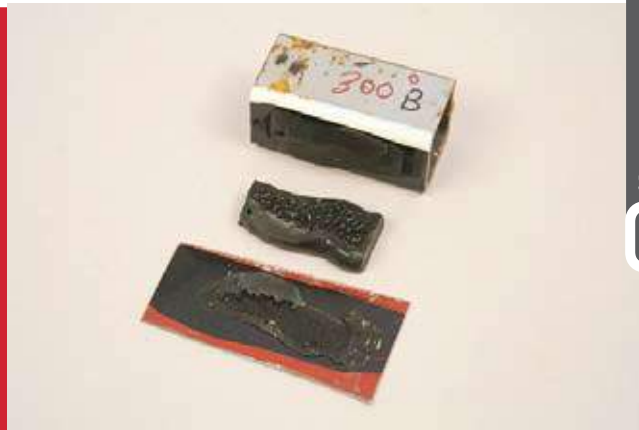
Figure 3 - The sample shows substantial degradation of the urethane adhesive.

We applied the recommended pinchweld primer to both the painted coupons and the steel tubing, and bonded them together with the glass urethane. The samples were allowed to fully cure before heating them in a small convection oven. The samples were heated to 121°C (250°F), 149°C (300°F), and 177°C (350°F). Each sample was left in the oven for ten minutes once the specified temperature was reached. The samples were then removed from the oven and allowed to cool to room temperature. The urethane on the samples that reached 149°C (300°F) and 177°C (350°F) expanded and the adhesion to the pinchweld primer failed (see Figure 3). The samples were able to be pulled apart by hand relatively easily. The urethane on the 121°C (250°F) sample did not show any obvious signs of degradation, however the temperatures of the samples were monitored using a non-contact thermometer and should not be considered exact.

The basic intention was to determine if excessive heat has the potential to adversely affect the urethane adhesive that bonds the glass to the vehicle. In the test we conducted, we found that it does. Knowing this, industry professionals may want to consider complete replacement of the urethane adhesive when replacing heat-damaged stationary glass.

This would require completely removing any remaining adhesive after the glass has been removed, without leaving an existing 1 or 2 mm adhesive bed as would be done when normally removing and reinstalling the glass. Refer to vehicle-specific service information or the adhesive manufacturer's procedures to determine how the vehicle flange and glass should be prepared for re-bonding.
