# GM Holden Overlap Sectioning Joint

## **GM Holden releases sectioning replacement options for the VE Commodore Sedans and Sportwagon.**

## GM Holden VE Ute rear quarter panel replacement.

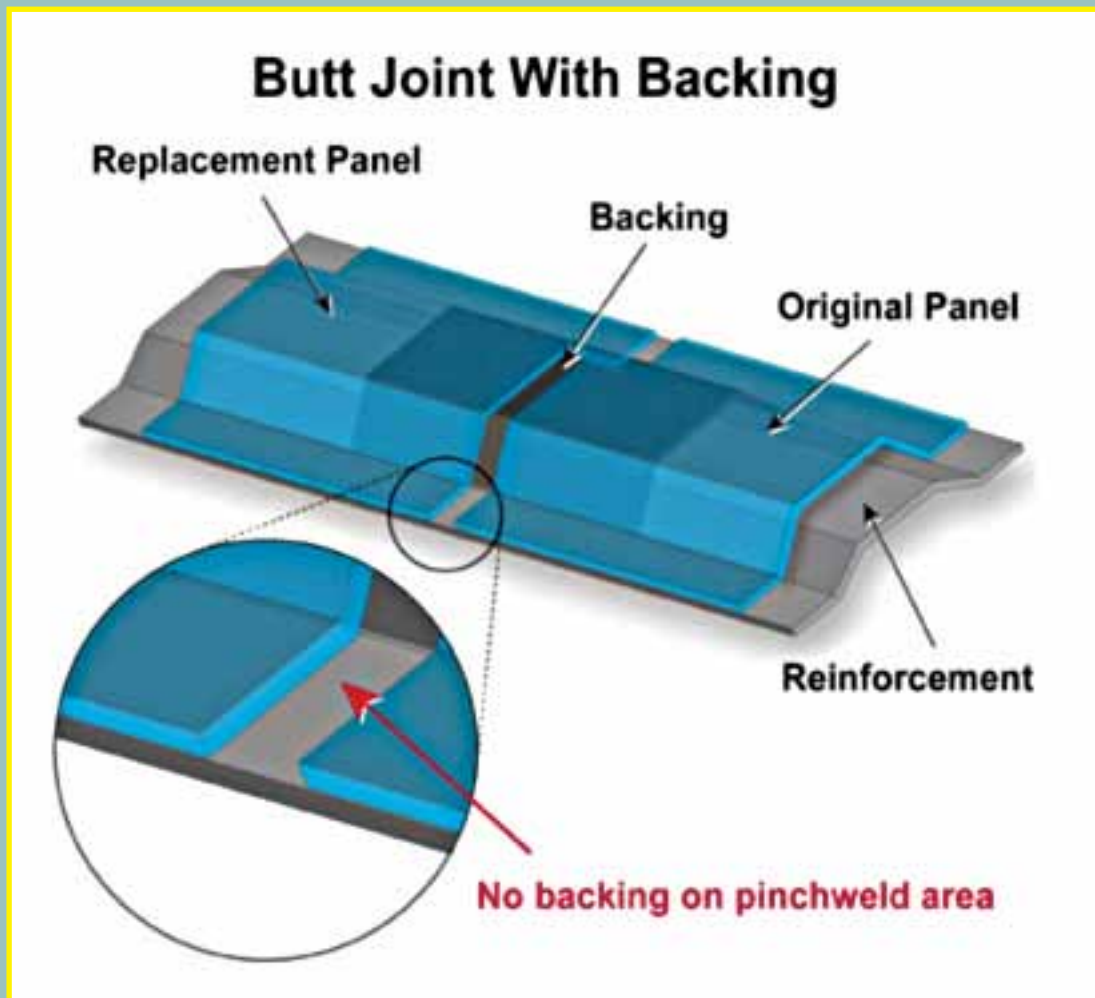
Until recently, GM Holden has generally specified butt joints with backings when sectioning parts of a uniside. However, an overlap joint is now being required for some uniside sectioning joints. This is being done to reduce the transfer of heat from GMA (MIG) welding into heat-sensitive high- and ultra-high-strength steel reinforcements. The concern with a butt joint with backing is that the backing piece does not extend to the pinchweld flange, and leaves the reinforcement exposed. As a result, a GMA (MIG) weld is made on the pinchweld flange area of the reinforcement (see Figure 1).

*Figure 1 - Because the backing does not extend to the pinchweld flange, a portion of the seam weld would be made directly on the reinforcement.*

The overlap joint specified in some new GM Holden repair procedures is made by cutting the replacement part to overlap the original part on the vehicle 25 mm. The overlap allows the original panel to serve as a backing for the seam weld, even on the pinchweld flanges, better protecting the reinforcement from the heat of the weld (see Figure 2). This is also a less complicated process compared to a butt joint with backing, and reduces the chance for cutting the replacement part too short.

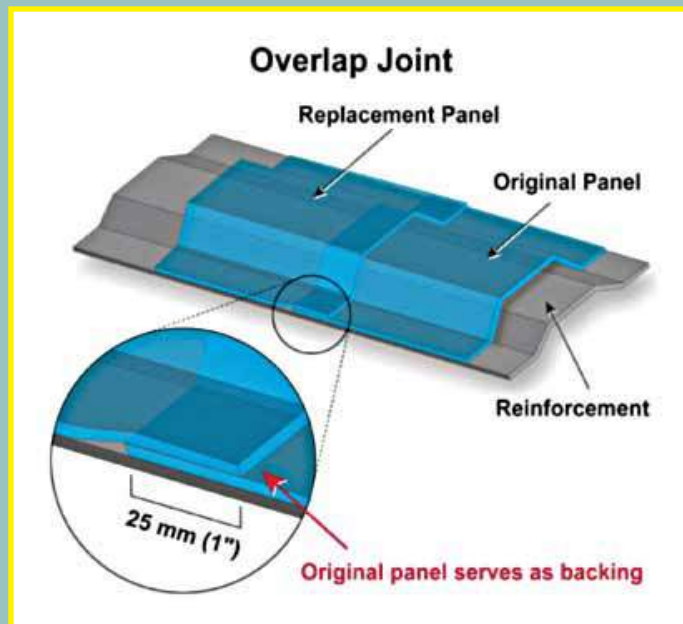
*Figure 2 - The original panel serves as a backing, and protects the reinforcement from welding heat.*

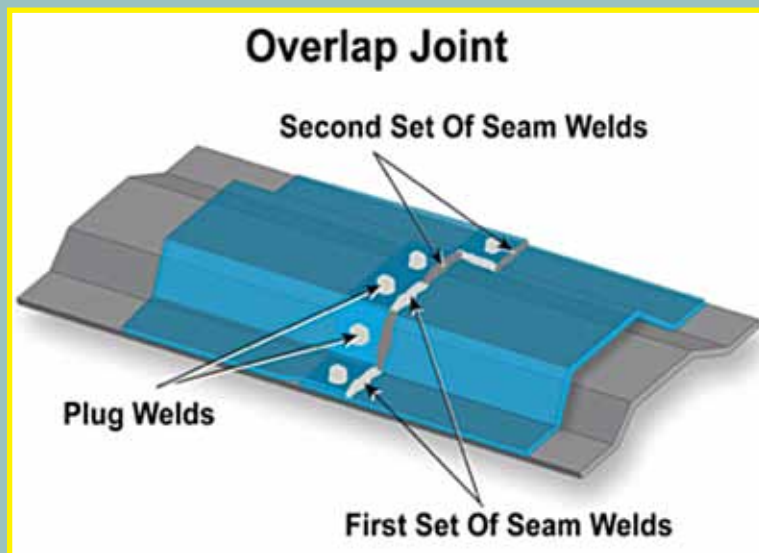
*Figure 3 - The first set of seam welds should leave a 25 mm (1 inch) gap between each weld. The second set of seam welds fill in the gaps.*

recommendation varies according to the procedure. The fillet weld should be made using a skip or stitch technique to minimize the chance for heat distortion. This is done by making 25 mm welds along the seam with 25 mm gaps between each weld, and then going back to fill in the gaps. (See Figure 3)

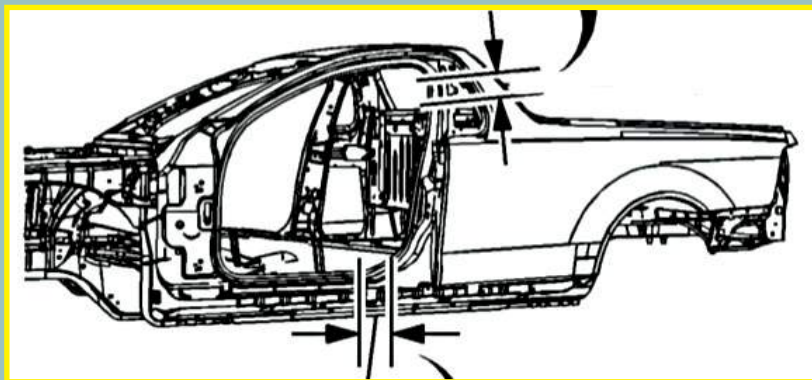
Fig 1. B Pillar outer

The illustration in Fig.1 below shows the joint areas where the panel should be fitted, however you will need the full repair procedure when fitting, as the outer skin is the easy bit. Panel fitting instructions are an 11 page document that shows how sealers and baffles should be installed while the outer panel is removed, (see inner structure in Fig.2) then the panel must be installed before these sealers cure. Perhaps something new for our industry is that the instructions also explain how the cabin must be pressurized to check for any air leakage.
