THREE-LAYERED PANEL

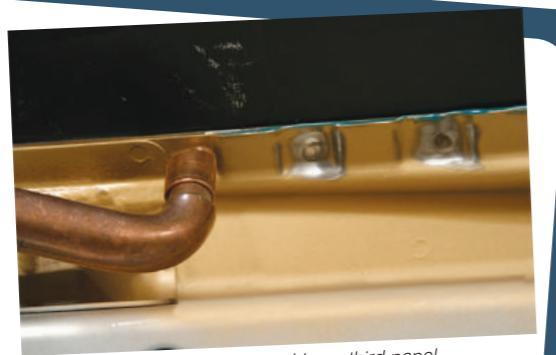
Figure 1 - When attaching a third panel to an originally weld-bonded panel, the recommendation from at least two vehicle makers is to use no adhesive and the original weld locations.

The exception to the rule about spot welding in the same spot is from Audi and BMW when attaching a third replacement panel, such as a replacement outer panel, to an already weld-bonded joint. The recommendation is to fit-up the third panel with no adhesive, and locate the spot welds using the original spot weld locations (see Figure 1 and the illustration in Figure 2). The reasoning is that
