Windshield pinchweld corrosion repair

JUL / AUG
07

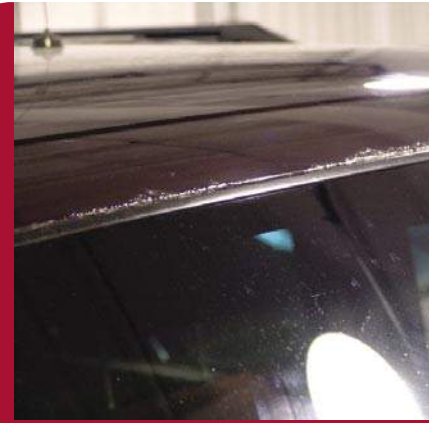
Figure 1 - Corrosion along the windshield pinchweld can cause leaks into the vehicle interior.

CORROSION occurs from a breakdown of the coatings, allowing moisture and air to come into contact with the exposed metal (see Figure 1). The repair must ensure that the metal is completely sealed from the elements to prevent corrosion from reoccurring after the windshield is reinstalled. It also requires that all corrosion be removed before reapplying primers and adhesive to the pinchweld area.

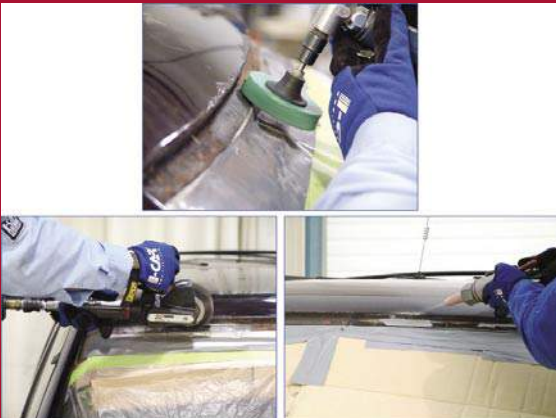
Figure 4 - Common methods of corrosion removal include using a plastic-coated abrasive wheel, wire wheel, and a media blaster.

Corrosion can be removed from the pinchweld using either a plastic-coated abrasive wheel, wire wheel, or media blaster (see Figure 4). Regardless of which method is used, it's important to minimize thinning the metal during the corrosion removal process. If body repair was completed on the pinchweld, it's important that filler not be used. Windshields should not be installed over body filler. This would be a weak link. The body of the urethane adhesive fills in minor irregularities on the pinchweld.

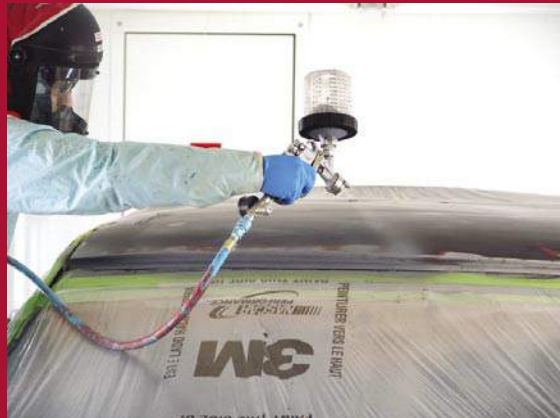
Figure 5 - Anti-corrosion primer must be applied to the pinchweld to reinstall corrosion protection over the bare steel.

Once all the corrosion is removed from the surface of the pinchweld, corrosion-resistant primer must be applied (see Figure 5). If areas adjacent to the pinchweld are also being refinished, use a primer that is recommended by the refinish system.

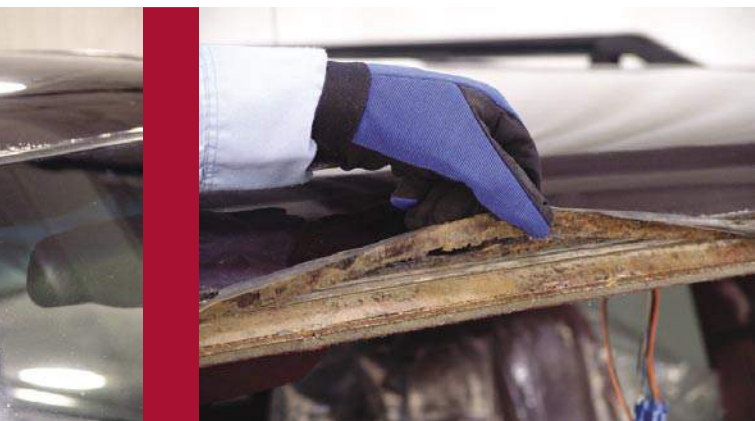
Figure 2 - This vehicle has extensive corrosion damage beneath the urethane that may have inhibited the safety features of the windshield.

With the glass removed, examine the pinchweld, looking for all areas that are contaminated by corrosion or scratched during the removal process (see Figure 2). These areas must be properly repaired before applying a new bead of urethane. Typically, pinchweld primer will work well for repairing minor scratches on a pinchweld. However, damage to a panel beyond the pinchweld may require a spot repair of the finish.

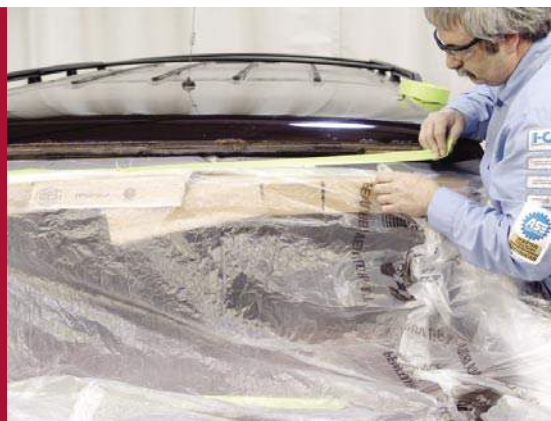
Figure 3 - The vehicle interior must be protected from the repair process.

Before beginning the corrosion repair process, mask off the windshield opening area (see Figure 3). This helps ensure that dust and particles from the repair process don't end up in the defroster vents, or anywhere else in the vehicle interior. Also protect adjacent areas.

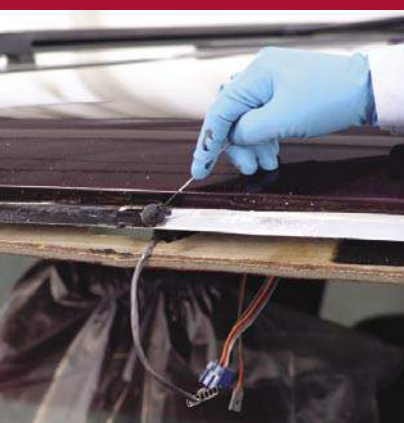
Figure 6 - Pinchweld primer, specific to the urethane being applied, must be applied over the corrosion-resistant primer before applying the urethane.

Pinchweld primer, that is specific to the urethane adhesive, is now applied over the corrosion-resistant primer, making sure to not get the pinchweld primer on any of the existing urethane (see Figure 6). After the pinchweld primer is applied, the windshield is test fit and prepped, the existing urethane is trimmed, the new urethane bead is applied, and the glass is reinstalled.
