### TECHNICAL REPORT

# DON'T SECTION ULTRA-HIGH-STRENGTH STEEL I-CAR Repairability Summit Identifies Best Practices

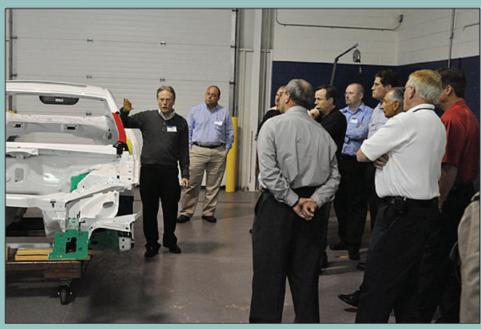
laid out like a repair plan. After the discussion on steel strength identification, the group discussed best practices for anchoring and pulling and different removal methods. The created heat-affect zone from heating and removal methods was a major discussion point. A discussion on attachment methods focused on GMA (MIG) welding heat-effect on UHSS, the changes in spot weld machine settings, and how destructive testing of spot welds differs on UHSS panels compared to HSS or mild steel. Somewhat new attachment methods like MIG brazing and self-piercing rivet bonding were discussed, including the applications where they are recommended and possible future uses (see photo below).
