# GM Holden Overlap Sectioning Joint

## **GM Holden releases sectioning replacement options for the VE Commodore Sedans and Sportwagon.**

## GM Holden VE Ute rear quarter panel replacement.

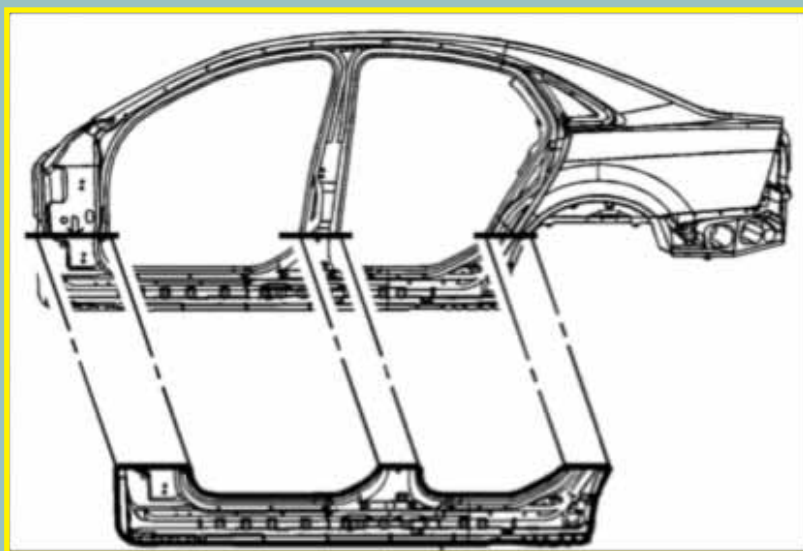
**Fig 1. B Pillar outer**

The following illustrations show the new partial replacement repair options for the VE Holden SWB and LWB Sedan and Sportwagon. These new repair options will reduce the need for replacing the whole body outer side panel after minor damage as has been the case until now. These options are now available for replacing the B Pillar outer (Fig 1) and Sill (Rocker) outer panel (Fig 2), so along with the existing rear quarter sectioning option we now have a much wider range of repair methods that can be used. However make sure you get the full repair procedure with measurements and weld methods before starting any repairs. The full repair procedures are available from your GM Holden dealership when ordering the parts.
