# Porsche Cayenne rocker panel sectioning change

Porsche has revised a sectioning procedure on the Cayenne SUV. For those who have the occasion to work on these vehicles, the change is worthy of note.

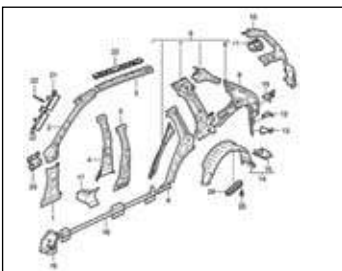
The new procedure adds two possible sectioning locations in the outer rocker panel, at either of the two shaded areas shown in Figure 2. This allows replacement of only small portions of the outer rocker panel. What does not change, is that no matter how much of the outer rocker panel is replaced, the replacement portion must be cut out of the front outer aperture shown in Figure 3. In addition to the complete outer rocker panel, the front aperture service part includes the entire outer A-pillar, B-pillar, and the front portion of the roof rail. The outer quarter panel, which makes up the rest of the side aperture, is also available as a service part.

Figure 3 - This is the service part that the outer rocker panel must be cut from, no matter which procedure is used.
