We have come a long way in just a short time when it comes to keeping abreast of new vehicle design and build technology. Understanding these advanced vehicle assembly features and how this plays a big part in the way we repair these new vehicles is so important. New Zealand repairers are lucky that we have access to a lot of this information thanks to many of the NZ motor companies now sharing vehicle body repair information with us as a new model is released. A good example of this is the new GM Holden Malibu; this vehicle has not been released to the NZ market when this edition of PanelTalk was delivered. Having this technical information early, enables us to preview and advise those in the industry on any new design features or cautions they should be aware of before a new model arrives in their shop, and yes there are a few features and cautions with the Malibu. Some of the new Malibu design features

Let's look at the GM Holden Malibu

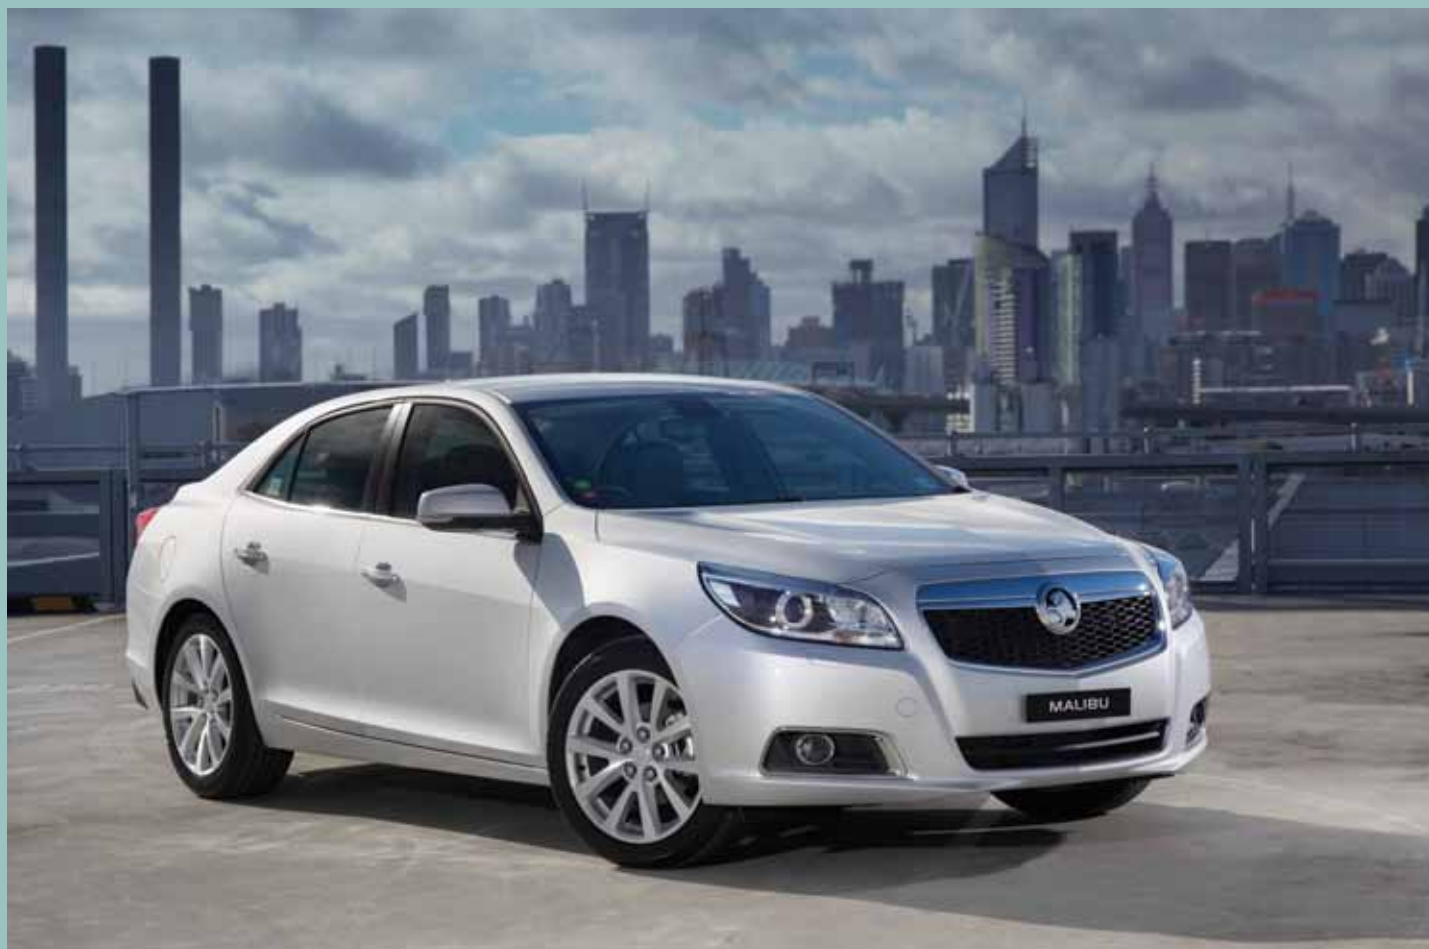
and repair methods might take a little while for some in this industry to get their head around, just look at the different steels used for the body structure shown in the cut away image in Fig. 1. As you would expect being a GM brand, the Malibu also has some repair methods very similar to the VE Holden Commodore.

Overall the new GM Holden Malibu has some good repair options, but because the body structure has such a wide range of different steels be sure to get the full repair method before replacing any structural or welded on panels.
