Body Repair Recommendations

I-CAR NZ plans to research and provide a Body Repair Technical awareness overview of a new release vehicle for each edition of PanelTalk, these will be for high volume models and brands, in this edition we look at the 2011 Holden Barina Spark.

for the Holden Barina Spark

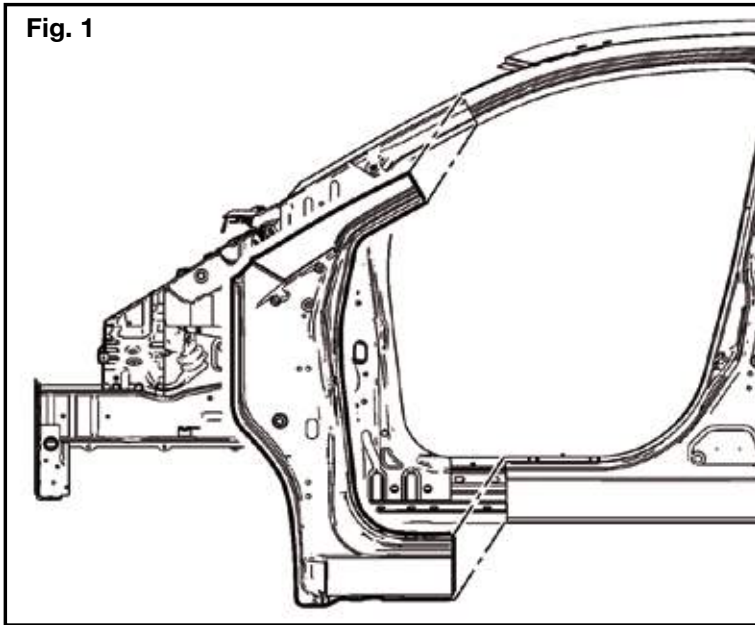
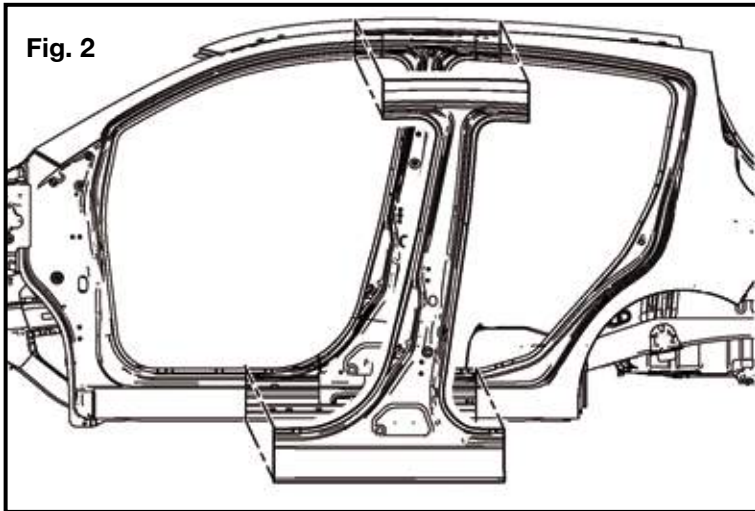
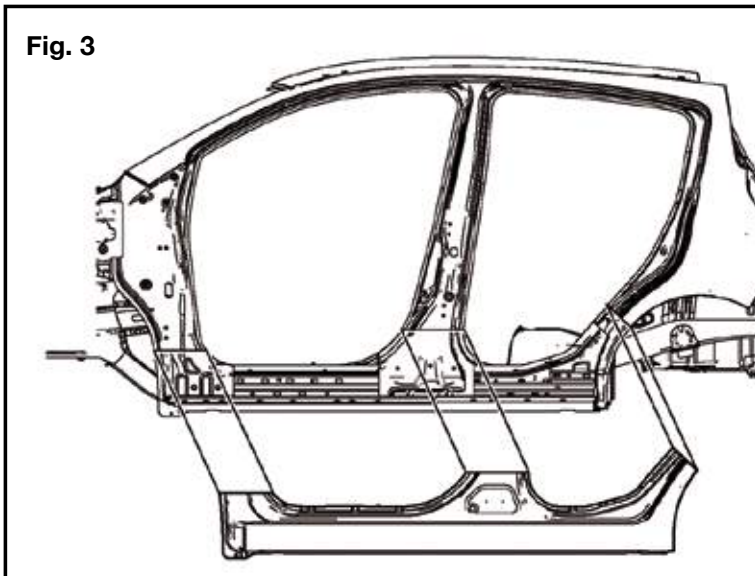
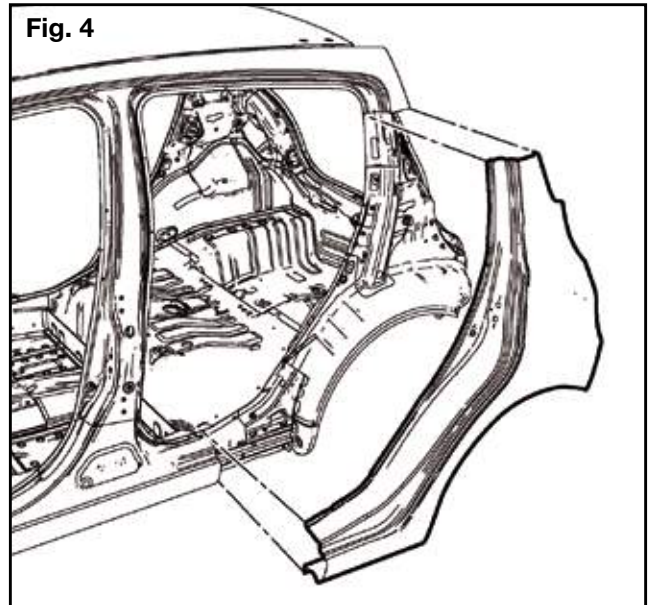
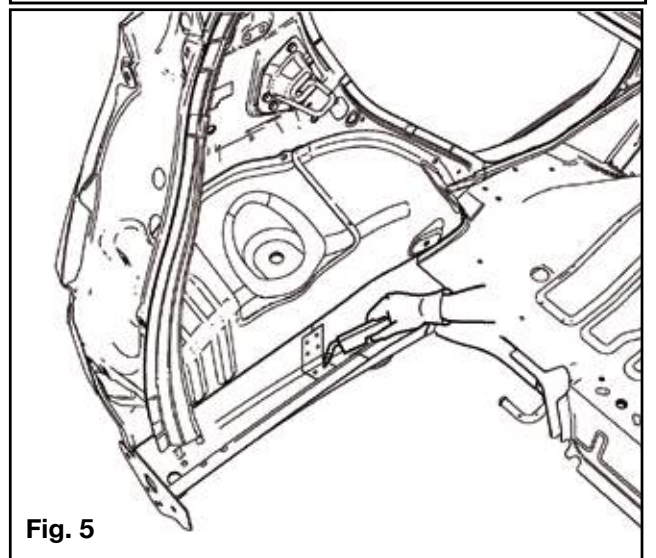
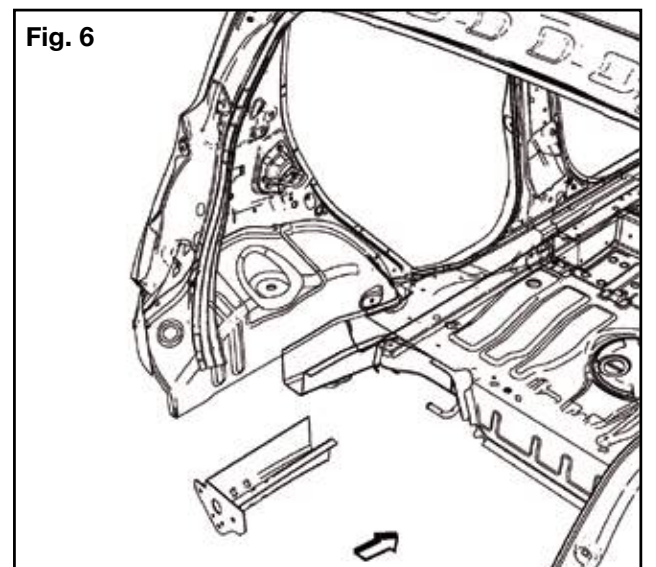
11. Prepare all mating surfaces as necessary.
12. Apply GM-approved weld-thru coating or equivalent to all mating surfaces. Refer to Anti-Corrosion Treatment and Repair.
13. Position and clamp or screw the backer plate with half of the backer plate exposed at the sectioning joint.

Note: Leave a gap of 1 1/2 times the thickness of the metal at the sectioning joint to the original panel.

5. Fabricate a 100 mm (4 in) backer plate for the rocker panel.
6. Drill 8 mm (5/16 in) plug weld holes as necessary in the locations noted from the original panel.

7. Bevel the sail panel and service panel edges at the sectioned area to approximately 10 degrees.
8. Grind a 50 mm (2 in) area of the outer surface on the vehicle to remove any corrosion, E-coat, primers, coatings and galvanizing that may be present.

9. At the section area on the service panel, grind a 50 mm (2 in) area of the back side to remove any corrosion, E-coat, primers, coatings and galvanizing that may be present.
