# Keeping up with new repair techniques

Compiled by Robert Renwick, CRA I-Car course coordinator

In this issue of PanelTalk we look at Toyota and in particular the 2003 Corolla. The Toyota Corolla is a pedigree of its own with well over 22 million built since its introduction back in 1966.

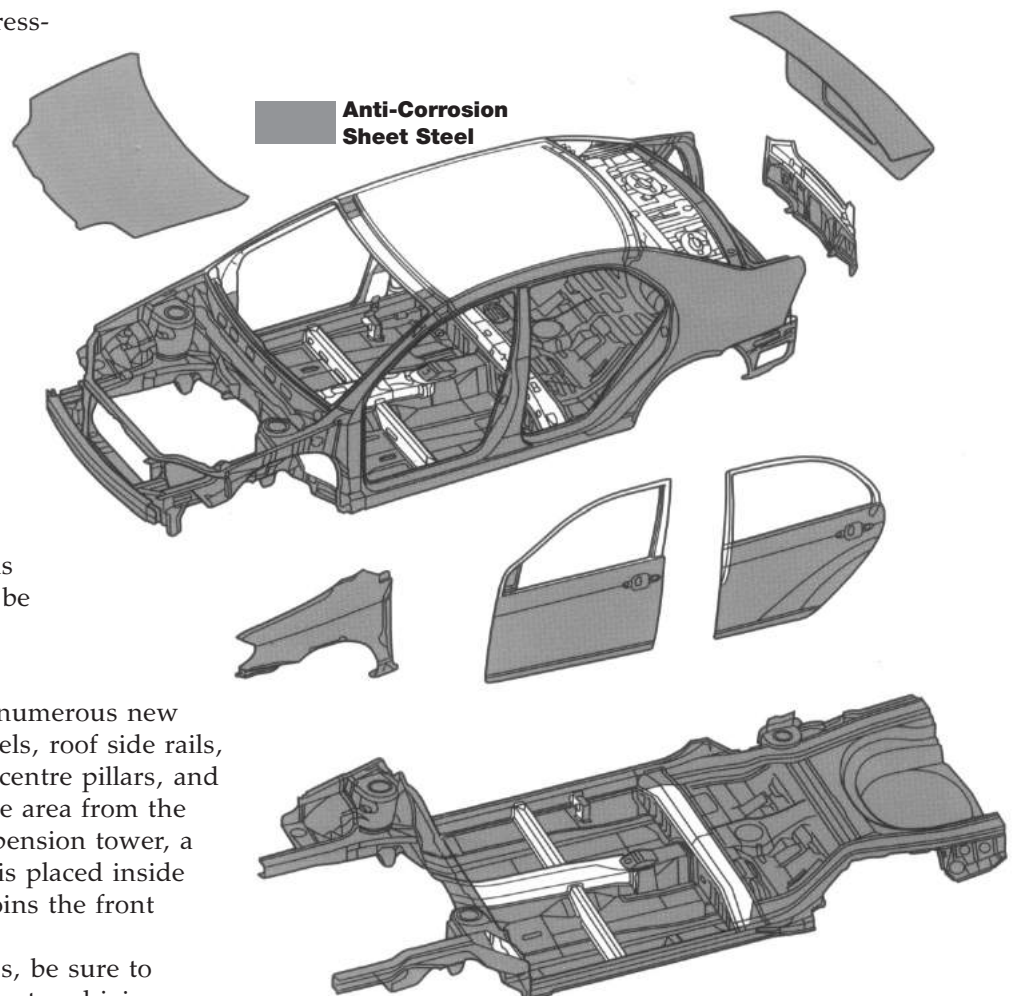
Figure 1. Panels made of anti-corrosion sheet steel.

Other than the roof panel and some inner reinforcements, as shown in figure 1, the body is constructed using anti-corrosion sheet steel. This must be taken into consideration when repairing any panels as applying body fillers and two component polyputties over bare anti-corrosion steel may result in inadequate adhesion. Blistering or peeling may result. An epoxy primer must first be applied to the bare metal before application of body filler.
