## Interpreting the Body Repair Manual

Following on from the technical report featured in the last edition of PanelTalk, we will examine our second place getter in the number of requests received for technical information and body replacement procedures - that place goes to Toyota.

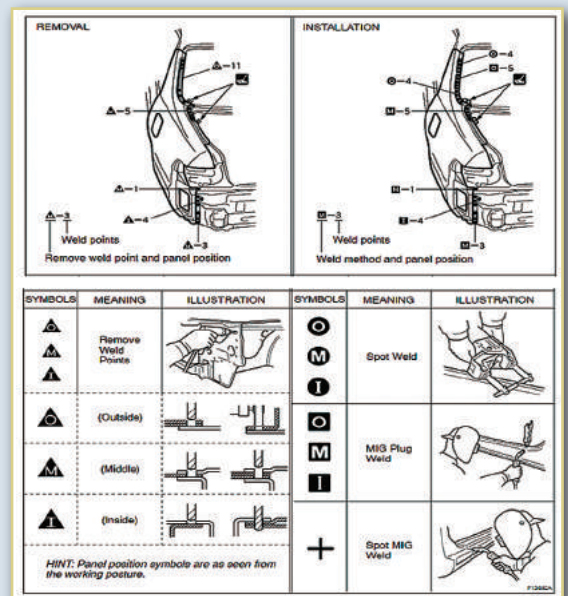
fig. 1

Secondly is being aware of, and understanding Toyota's welding, cutting and fitting symbols that appear in the replacement procedures - many of these documents include symbol identification, but there are those that do not - the technician must be able to refer back to Toyota's general recommendations and symbol identification information to ensure that the procedure is completed correctly, in accordance with the repair manual. (See figs 1 & 2)
