TECHNICAL I-CAR[®] NEW ZEALAND REPORT

REPAIR PROCEDURES AND THE BIGGER PICTURE

- WHAT COULD
COLLISION REPAIRERS
BE DOING BETTER ??

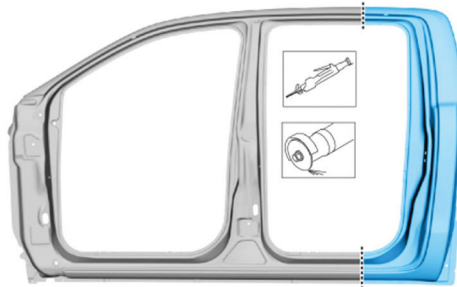
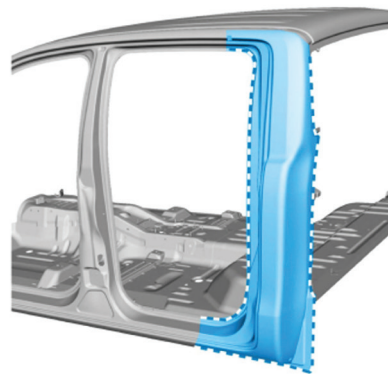
Excerpts from the C pillar procedure :

The repair procedure found in the Ford BRM describes replacing the C pillar reinforcement, which also includes cutting and sectioning the outer panel. As the reinforcement can only be replaced at the factory joints, the outer panel requires cutting away down into the sill /rocker, as well as up into the roof / cant rail area (as per the “service condition” of the supply part).

The area in question was the outer C Pillar which is damaged extensively and requires replacement. The repairer requested and received the repair procedure from the local Ford dealership for this part. While the method was described correctly, there was a misinterpretation on what the appropriate repair scenario should be – brought about by a lack of understanding of the BRM.

As this procedure is the only one supplied by Ford for the C pillar, the assumption was made (incorrectly), that the outer panel can only be cut and welded as per that method.

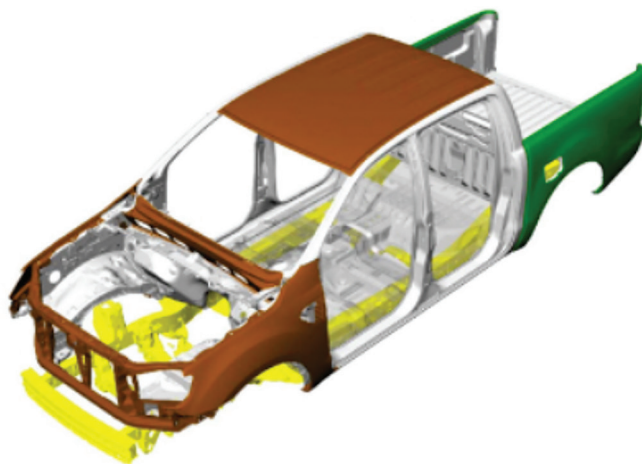
High-strength and super-high-strength steels

Other critical information found in the Ford Ranger BRM :-
