Aluminium and steel hybrid-structured vehicles; the design of the future?

I-CAR

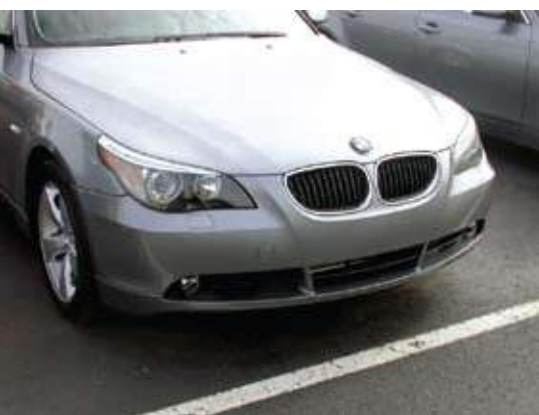
Figure 1 - The BMW 5 Series front structure is made from aluminium, while the area rearward of the cowl is made of steel.

In 2004, BMW introduced the 5 Series with a front structure made from aluminium and a rear structure made from steel. The most interesting characteristic about this vehicle, from a collision repair perspective, is its construction. The front-end structure from the cowl forward is all-aluminium, while the rest of the vehicle structure is steel. The front portion of the lower rails is aluminium; the portion of the lower rails under the floor pan is steel. A rear portion of the upper rails is steel, however the rest of the upper rails are made of aluminium. The floor pan and the lower portion of the A-pillars are steel, both joined to an aluminium cowl panel.

Aluminium part construction used for vehicles is either stamped, extruded, or cast, and the 5 Series uses each of these in the front-end structure. The strut tower/apron assemblies are cast construction. The inner part of the lower rails (engine carriers) are extruded construction, while the outer portion is stamped. The upper cowl panel is extruded and hydroformed. The upper rails and cowl panels are stamped. The alloys are 5000 and 6000 series.

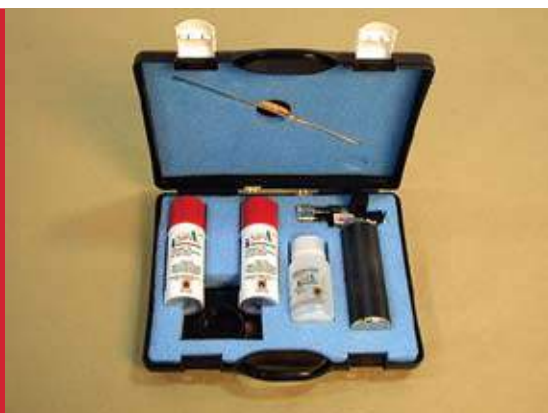
Figure 2—The Pyrosil® (flame) kit is used to prep flanges for adhesive application.

Preparation of the flanges for adhesive is done with a Pyrosil® (flame) kit (see Figure

2). This is the same process used on the 2004 Jaguar XJ. The flame is applied to the flange. While the flange is still warm, adhesive primer is applied. After allowing the primer to dry, adhesive is applied.

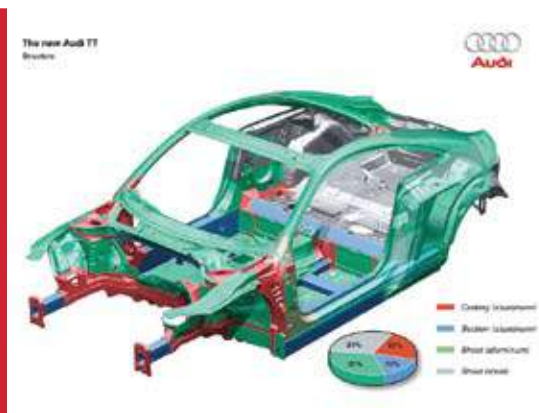
Figure 3 - The Audi TT Space Frame is nearly 70% aluminium. (Photo courtesy of Audi of America)

The all-new 2007 Audi TT Coupe and Audi TT Roadster are both built using the Audi Space Frame (ASF)® concept. Different from traditional ASF vehicles that are made from aluminium, the ASF is made from both aluminium and steel for structural parts. The ASF® on the Audi TT Coupe (see Figure 3) is made of nearly 70% aluminium, with the remaining 30% being steel unitized construction. The use of aluminium over traditional construction materials creates a 48% weight savings and 50% higher torsional rigidity, meaning there is much less flex in the vehicle structure. The total weight of the space frame with the exterior body panels attached is approximately 277 kg (610 lb). The biggest advantage is that steel is used in areas where additional weight is desired. The steel unitized structure provides additional weight to the rear axle, creating more down force to the rear wheels and a more efficient balance between the front wheels and rear wheels. Steel is also used for the door shells and rear hatch.

The aluminium portion of the Audi TT space frame is made up of castings, extrusions, and stampings. Castings make up 22% of the Audi TT Coupe structure, and 18% of the structure of the Audi TT Roadster. Aluminium extrusions make up 16% of the structure on the Coupe and 22% on the Roadster. Steel

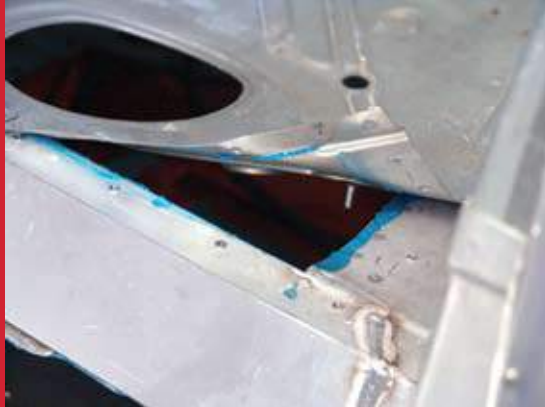
Figure 4 - The adhesive provides protection against galvanic corrosion where steel and aluminium are joined.

Galvanic corrosion occurs when two dissimilar metals are in contact with the presence of an electrolyte. An electrolyte is a non-metallic conductor of electricity. Water and salt water are examples of electrolyte that vehicles are typically exposed to. When galvanic corrosion occurs, the more active of two metals transfers electrons to the less active metal. During galvanic corrosion between aluminium and steel, aluminium becomes the anode. The anodic metal is more active and corrodes faster than it would by itself. The anodic metal is sacrificial and corrodes to protect the other metal. The steel becomes the cathode. The cathodic metal is less active and corrodes slower than it would by itself. Steel is cathodic to aluminium. Due to both metals being used on the space frame, there are specific concerns with galvanic corrosion. During the vehicle manufacturing process, all of the connections between aluminium and steel are insulated with a nonconductive structural adhesive (see Figure 4). In addition to the adhesive, there may be another fastening method, including self-piercing rivets, clinches, or rolled hem joints. The cured adhesive also seals the flange, preventing any electrolyte from being introduced to the joint.

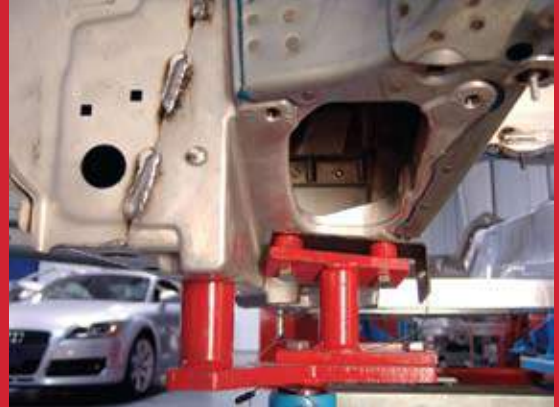
Figure 5 - The torque boxes on the Audi TT are made from cast aluminium.

Another concern is that steel and aluminium have different tensile strengths. When straightening a hybrid structure, the aluminium will straighten at a different rate than the steel structure. Although the Audi repair information stops short of saying do not straighten the structure, as the BMW repair information for the 5 Series does, straightening the structure may cause the adhesively sealed joints to separate. This could potentially lead to galvanic corrosion. Due to the space frame design of the Audi TT, the vehicle torque boxes are constructed of cast aluminium (see Figure 5). There is a concern of adequately anchoring the structure on the aluminium castings and

straightening the structure, without causing damage to these parts. In most cases, the damaged parts will typically require removal and replacement.
