Advanced High-Strength Steels - A Collision Repair Perspective

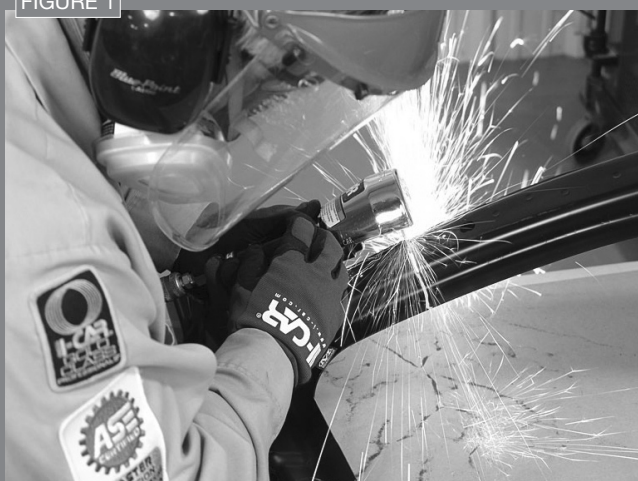
FIGURE 1

The inner B-pillar made from UHSS alloyed with boron is being cut with a cutoff wheel

(UHSS) alloyed with boron is the material that has received much notoriety over the past several years. Vehicle makers, such as Volvo, have made this boron-alloyed material an integral part of their vehicle design. Volvo models such as the S40 and V50 have the inner bumper rails and door intrusion beams made from steel alloyed with boron and the XC90 uses the material for B-pillar inner reinforcements (see Figure 1), the centre roof bow, and inner rear body panels.

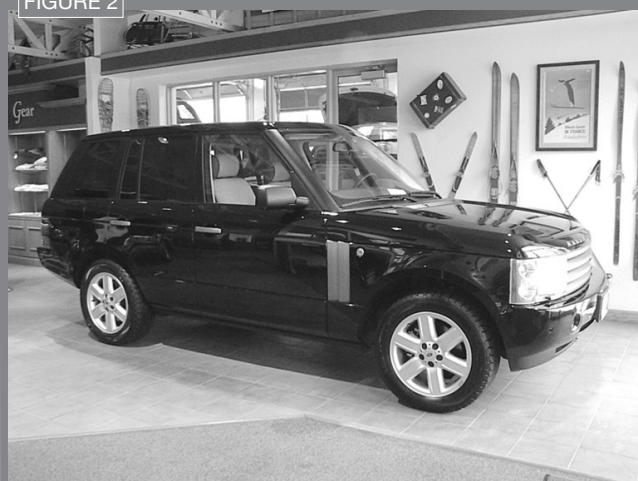
FIGURE 2

The Land Rover Range Rover Sport has specific recommendations for working on dual-phase steel

Land Rover's recommendation for replacing UHSS parts requires removing spot welds on the part that is adjacent to the UHSS part, which is typically high-strength or DP (see Figure 2). This is because, according to Land Rover, DP and normal high-strength steel pose no great issues.

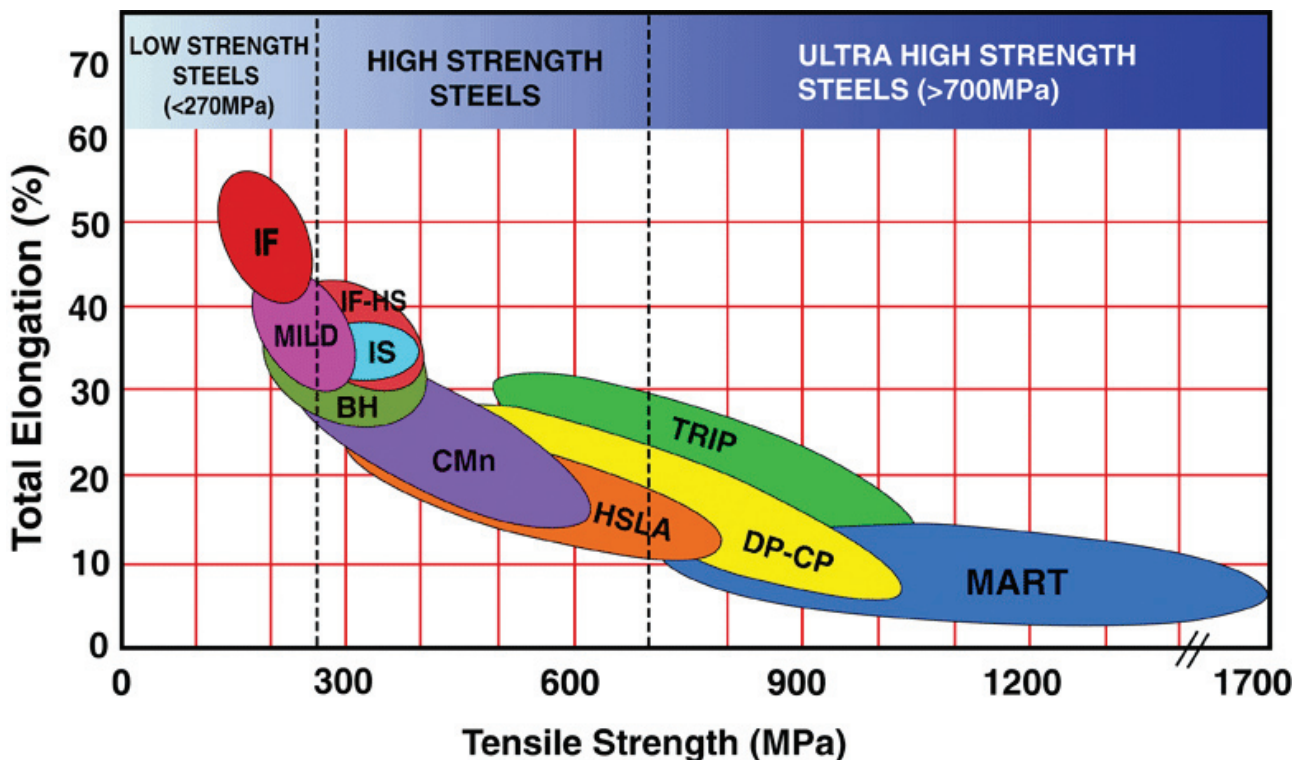
FIGURE 3

The chart in Figure 3 on the next page graphs strengths of different steels (tensile strength) to ease of being formed (malleability or elongation). It can be seen that lower-strength steels are much more malleable than martensitic steels. Note that the steel alloyed with boron is in the far right section of the blue martensitic category.

The chart also shows that some steel types overlap, depending on added properties. For example, some AHSS, such as some TRIP and DP steels, are stronger and less malleable than some martensitic steels.
